PASSAIC RIVER BASIN  
DEN BROOK, MORRIS COUNTY  
NEW JERSEY

**LEVEL II**  
**LAKE ESTLING DAM**  
**NJ 00184**

**PHASE 1 INSPECTION REPORT**  
**NATIONAL DAM SAFETY PROGRAM**

August, 1979

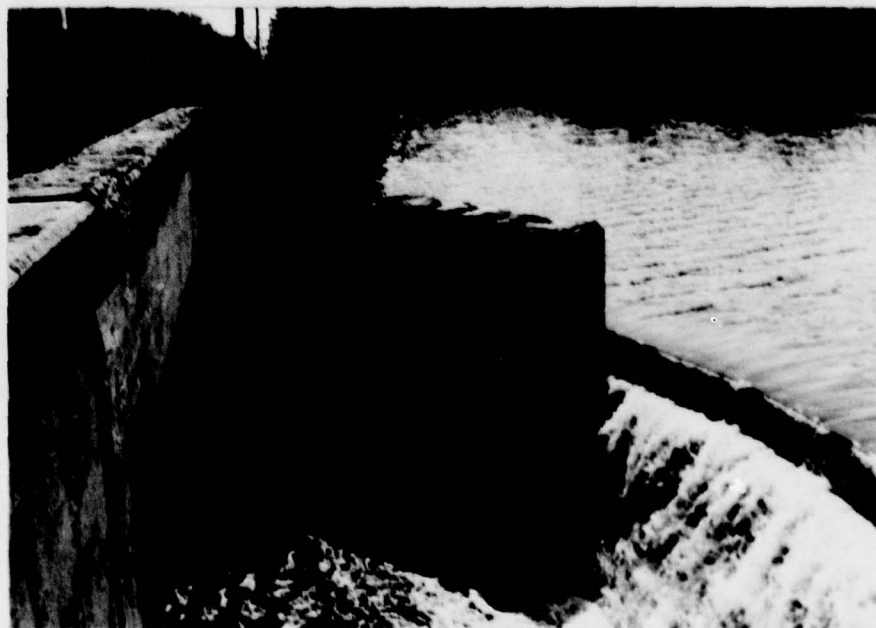
b. Appurtenant Structures. Leakage estimated at about 30 gpm was discharging from the third, fourth, and fifth joints from the top of each stone masonry abutment of the spillway weir. The mortar in the top joints of the abutments of the weir was spalled, cracked, and deteriorated, and the mortar in the joints closest to the spillway has eroded completely where it is in contact with the over-flowing water. The upstream face of the railroad culvert above the spillway discharge channel has numerous cracks and spalled areas.

RIGHT ABUTMENT

(6) In the near future, design and implement repairs for the abutments of the spillway to stop the leakage and to restore the stone masonry to good structural condition.

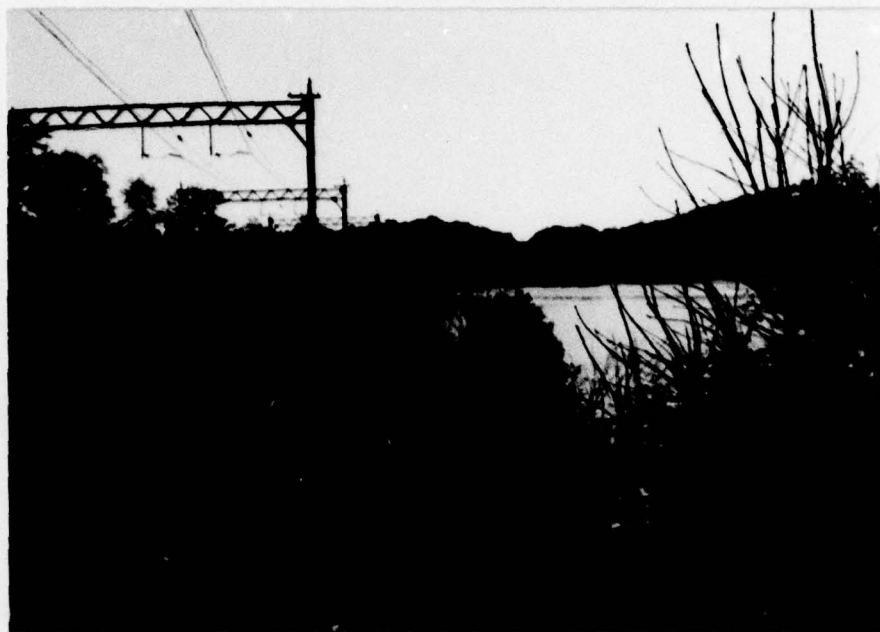
VIEW OF RAILROAD EMBANKMENT FROM LEFT ABUTMENT LOOKING EAST

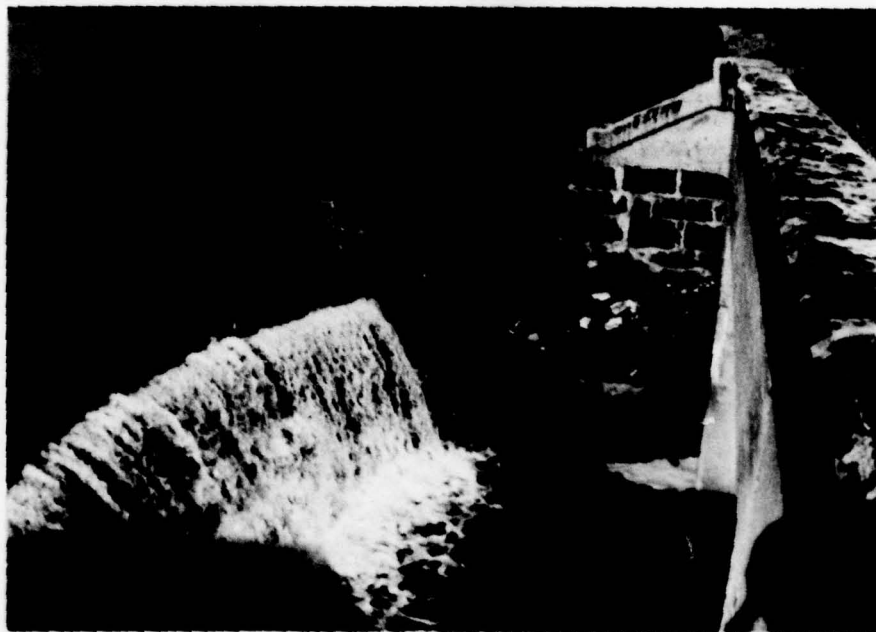
LEFT ABUTMENT

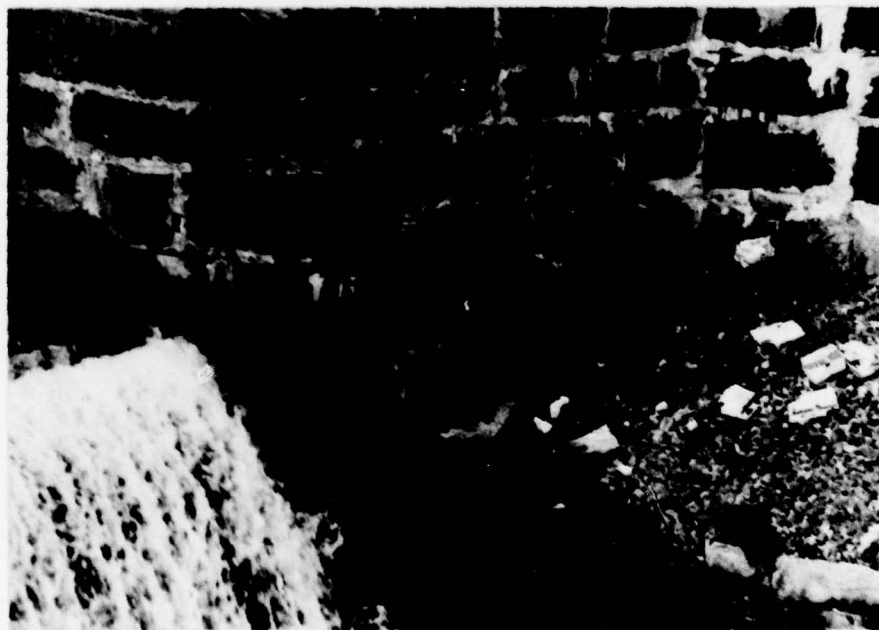
SEEPAGE AT LEFT ABUTMENT

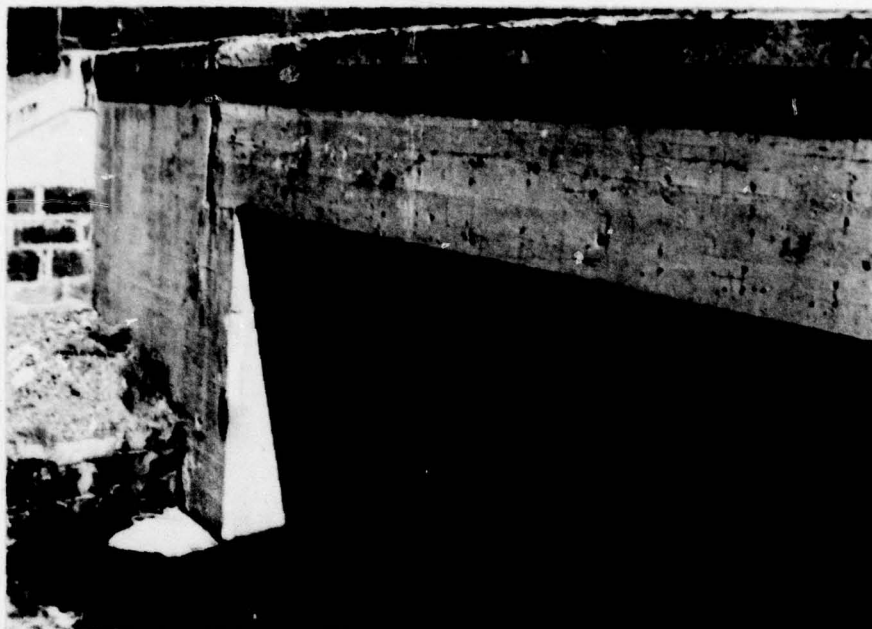
VIEW OF DOWNSTREAM CULVERT THROUGH RAILROAD EMBANKMENT

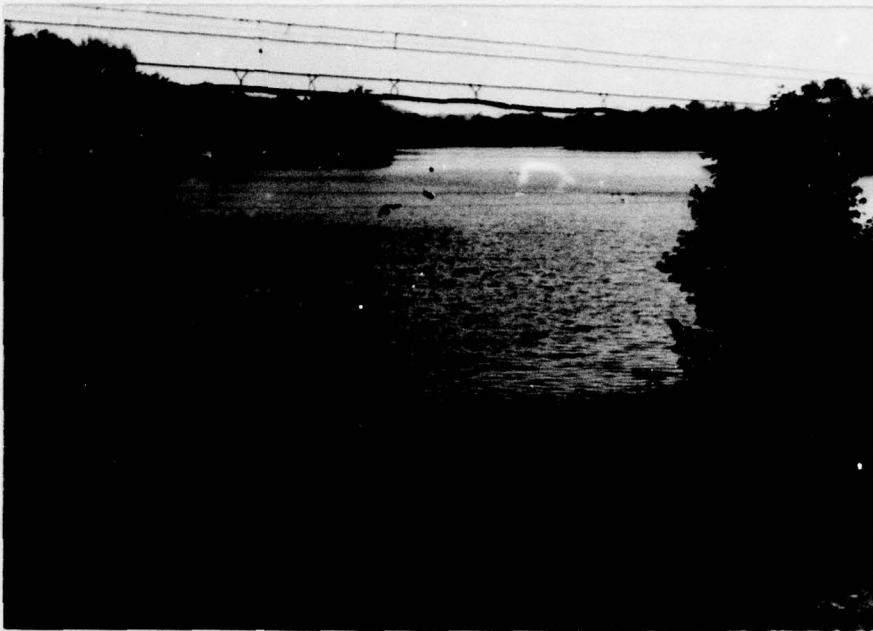
VIEW LOOKING DOWNSTREAM OF INDIAN LAKE FROM BRIDGE OVER SPILLWAY
